SPI CAMERA STATUS

ANNEALING 32th

- Annealing 32th Jan 20 Feb 6
- Duration 200hrs

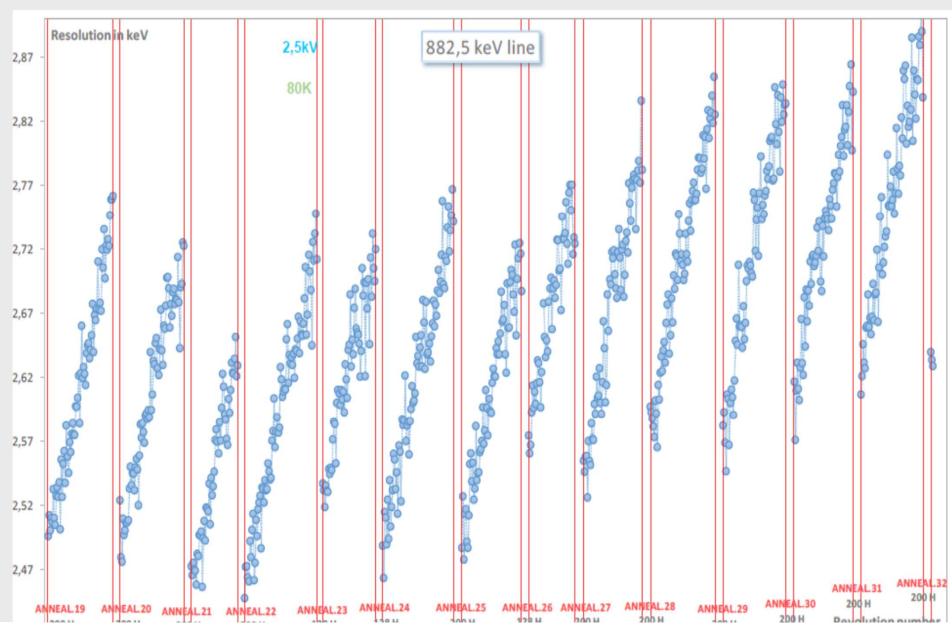
ENERGY RESOLUTION HISTORY: 882.5 keV

• Regular annealing (GeD at 105C) restore GeD energy resolution.

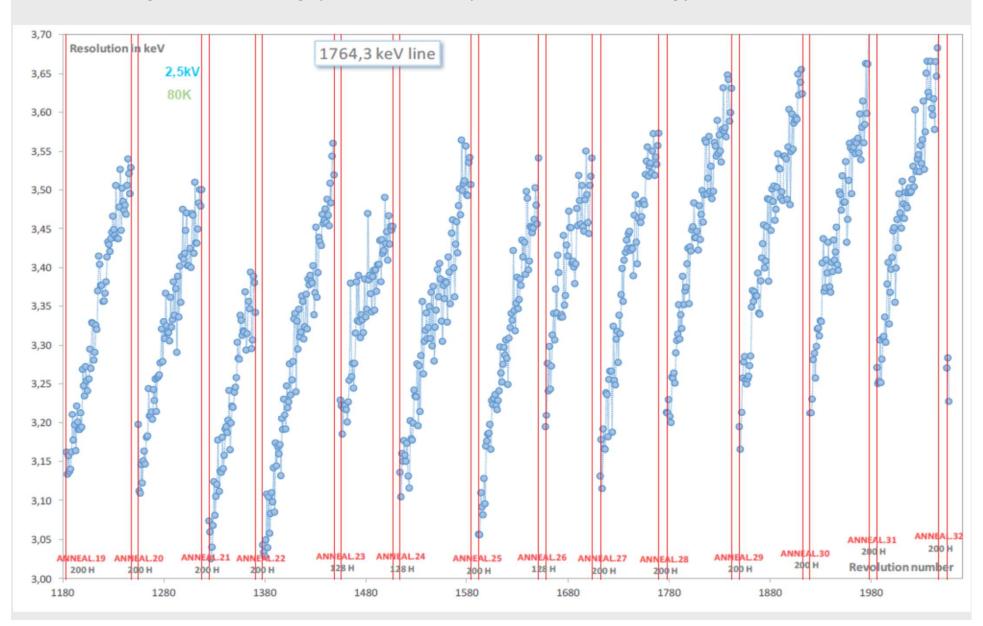
ENERGY RESOLUTION HISTORY: 1764.3 keV

Regular annealing (GeD at 105C) restore GeD energy resolution.

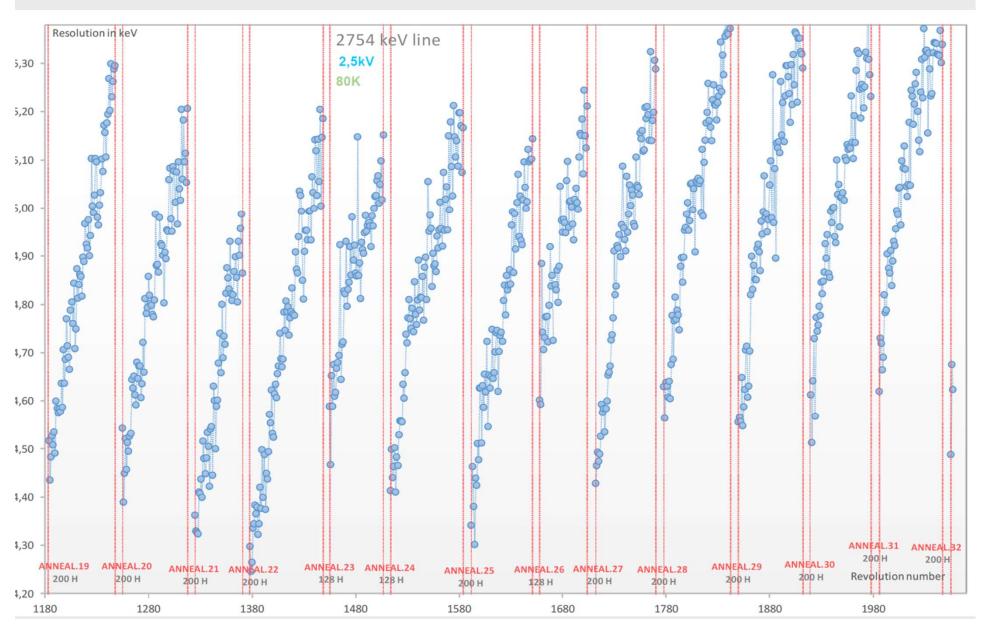
ENERGY RESOLUTION HISTORY: 2754 keV

• Regular annealing (GeD at 105C) restore GeD energy resolution.
