SPI Status

S. Fahmy ESA/ESOC
IOCG 23/02/2010

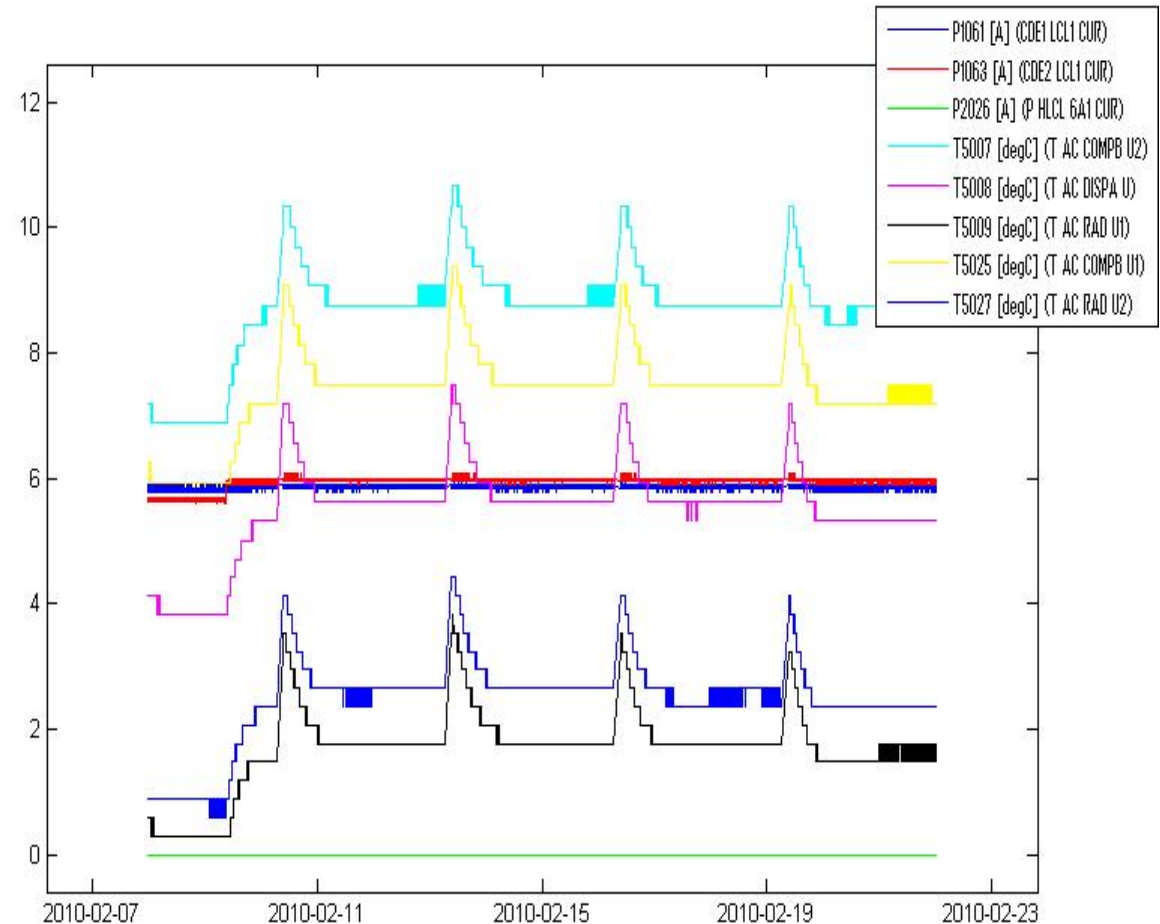
- **Compressor Stroke:**
 - **CDE1 stroke 43, LCL current 5.8A stable**
 - **CDE2 stroke 45, LCL current 5.9A stable (LCL trip off is at 7A)**
 - **Compressor temperatures in range and stable**
